Aircraft SE-BDY “Albertina”

Ndola 18 SEPTEMBER 1961

Accident Investigator’s Report

to the Hammarskjöld Commission

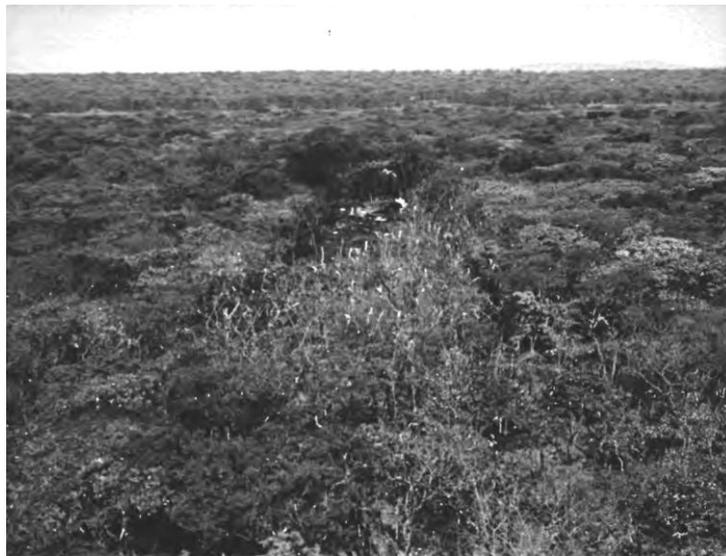
The swath cut ("crash street") (Fig 1) and the wreck distribution pattern show an investigator the manner in which the aircraft went down towards the ground (through the trees), hit the ground, wrecked and finally stopped. The evidence is documented in full transparency, in the presence of Transair's representatives, international investigators and the Swedish police (among others). There are excellent photographs of the swath cut, which appear consistent with some measurements performed in this present investigation. There is no conceivable way to create such a cut in the trees afterwards, so the approach path through the trees is a reliable fact.

*Fig 1. The swath cut in the trees and the accident site
(photo from the Report of the Rhodesian Commission of Inquiry).*

The swath cut and the distribution pattern contradict a number of theories of sabotage and aggression. There was, for example, no explosion causing parts to fall off from the aircraft while it was still airborne. In such an explosion, debris would have been found around the position of the blast, and there was no such sign found despite extensive search. Instead, the swath cut itself is the clearest evidence for CFIT, i.e. that the airplane was in a controlled flight until it struck the treetops and then continued in an almost normal angle of descent towards the ground.

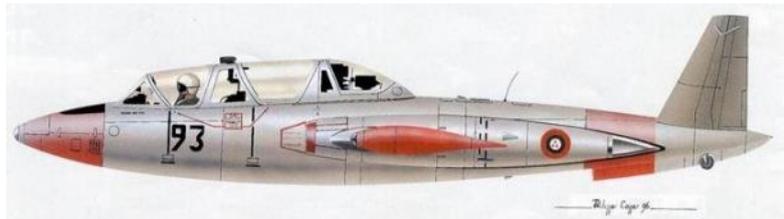
The Katangan Air Force – Aviation Katangaise, "KAT" or "Avikat" – was originally in possession of three Fouga CM 170 "Magister" (Fig 3), a two-seated small jet designed for training and light attack. Reportedly the only Fouga in operational order on 17-18 September 1961 was #93, based at Kolwezi Air Base. #91 crashed 23 June 1961, and #92 was located in Elisabethville (under UN control) and not operational since 11 July 1961 due to engine failure.

Fig 3. Sketch of Fouga #93, "KAT-93"

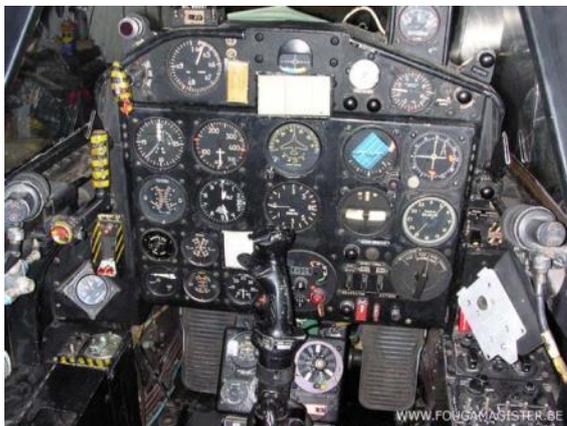
Fig 5. The Fouga's cockpit

- **Darkness capability.** Reportedly, there was no opportunity to fly in darkness with available equipment on the Fouga. I have not seen any indication that the Fouga carried out any attack other than during daytime; in fact, the Rhodesian Board is referring to local witnesses at Kolwezi stating that *"the Fouga had never been operated at night"* (p. 26) (fig 5). A comment on night flight limitation is, that if it is difficult to fly "as usual" in darkness with a particular aircraft, it is impossible to carry out the mission as a night fighter: i.e. to find and shoot
